Temporary structures at Steward Community Woodland

Introduction

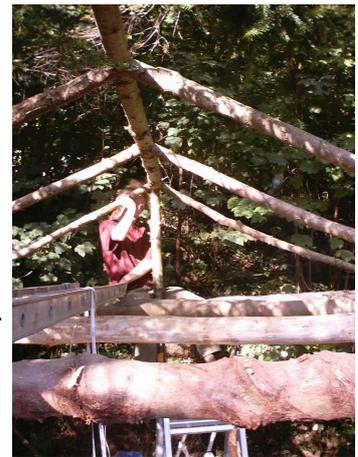
Illustration 1: Building of roundwood structure - Nov 2003

Most of the structures at SCW are built using round wood timber frames from wood harvested from the surrounding woodland. Some also contain sawn timber either reclaimed or from the woodland. They are mostly built on platforms raised off the ground. This minimises damp problems and also the impact on the landscape. No digging or terracing is required and in the event of them being removed the landscape remains unchanged. Some structures, particularly the kitchen, long house and bathhouse, are built on the ground and needed some levelling. This has the advantages of higher stability and lower visual impact as they are generally lower, along with more internal space, enabling sleeping platforms and storage above. The structures are clad with mainly reclaimed wooden boards and/or canvas and insulated with reclaimed blankets or other insulation. A small amount of new timber has been used on some structures where other resources were not available. The size of the structures varies but none are excessive for their needs.

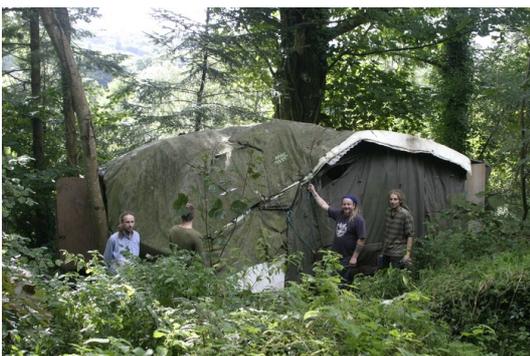
14:57 – The inside of the structure has already been emptied of stuff. We are about to begin the deconstruction process.

On 11th September 2008 we dismantled one of the structures in the woodland. It was a bender construction made from coppice wood and reclaimed timber, pallets and windows, clad with ex-army tarpaulin and insulated with second hand blankets. This structure was built in 2005 as a short term residence. Five people were involved in the deconstruction task. Below is an account of the process.

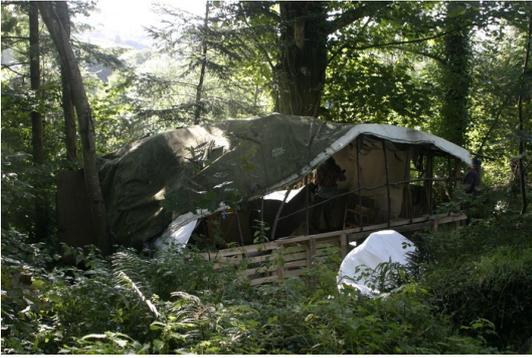
15:07 – The side wall comes off. This consisted of tarpaulin and blanket insulation

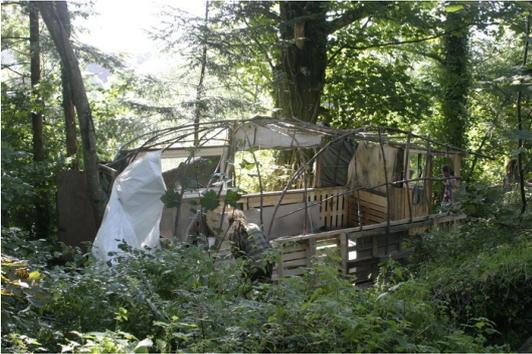
15:17 – Here we have removed the roof cover. Two tarpaulins, one waterproof insulating and one green army canvas. You can see the bender construction well in this shot.

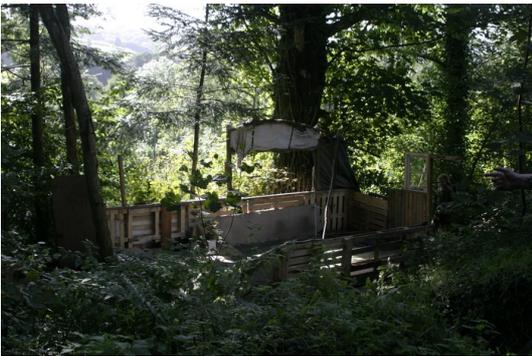
15:36 – The remaining walls were built from reclaimed pallets collected locally

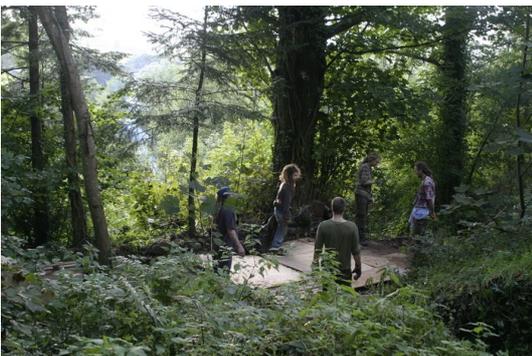
16:08 – Here just the floorboards and more pallets remain. This structure was sat straight on a flat piece of land.

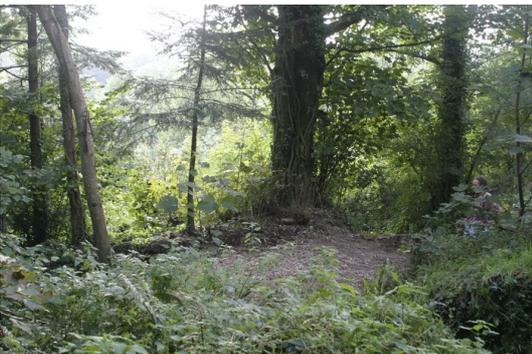
16:27 – All gone! There was still some work to do removing some of the materials. Most of these were reused or burned as firewood.

From beginning to end the deconstruction took just one and a half hours with five people.

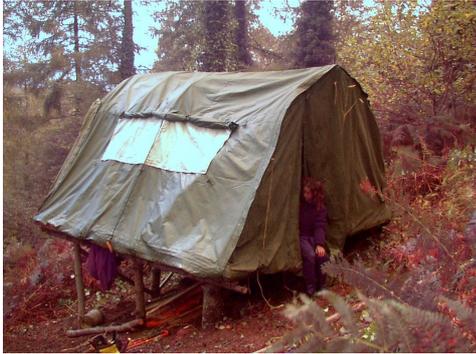
Illustration 2: Kat's bender built in 2000. This bender was dismantled in Autumn 2001.

Kat's bender above was built on a platform with stilts into the ground. Peter's bender at the site on the right was built directly onto the reasonably flat ground. We unfortunately don't have a photograph of the original structure.

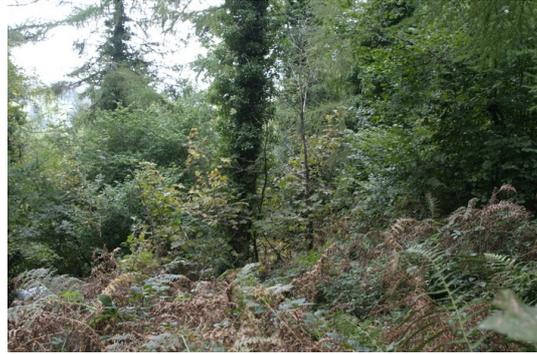
Illustration 3: The same site in Autumn 2008

We can see from these photographs that little or no impact is left on the land after structures have been removed.

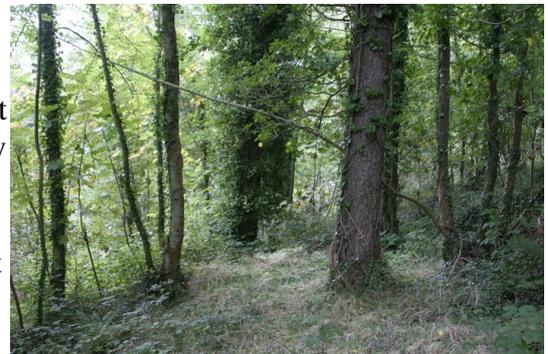
Illustration 4: Pete's old bender was built in 2000 and dismantled in 2001. This is the site in Autumn 2008.

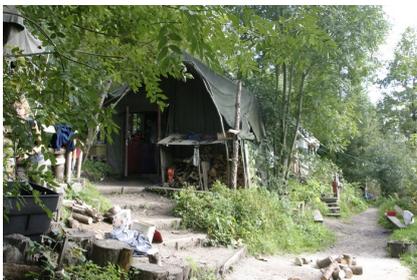
Illustration 5: The communal Kitchen built on the ground

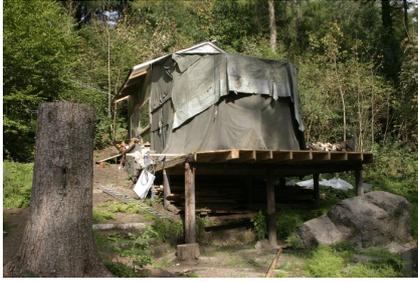
Illustration 8: Owen, Chris and family's dwelling recently built from sawn timber from the land, on stilts.

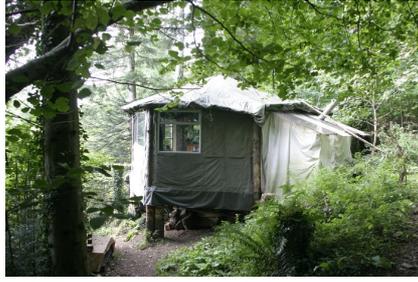
Illustration 9: Becky's roundhouse dwelling with Hogan Whirling Log roof.

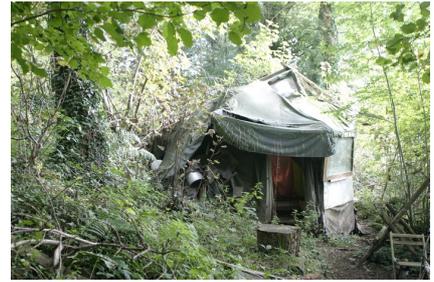
Illustration 10: Peter's house built directly on the ground.

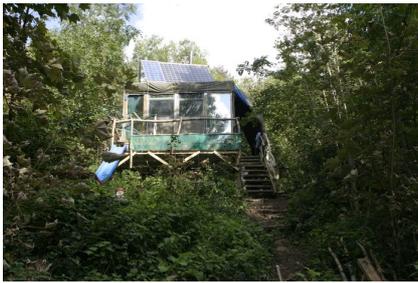
Illustration 11: Seth, Mel and family's house built on stilts.

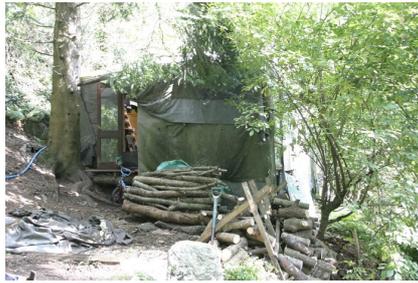
Illustration 12: Merlin, Beccy and Rowan's house on stilts.

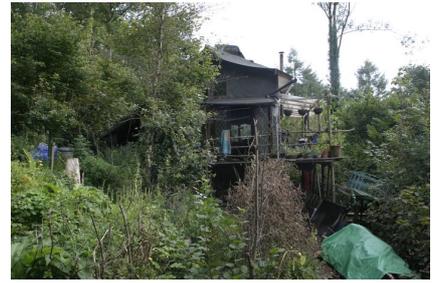
Illustration 13: John, Son and family's house built on stilts

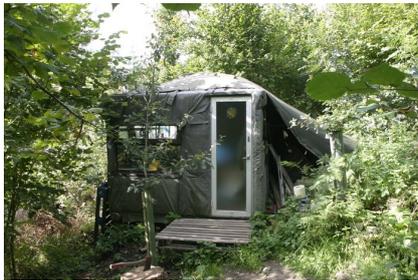
Illustration 14: The visitor bender built on the ground.

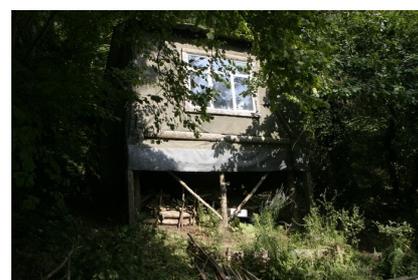
Illustration 15: Dan's dwelling built on stilts.
